Thermography for Building Inspections

ARCHIMEDES Facility-Management GmbH

VarioCAM® hr inspect 680

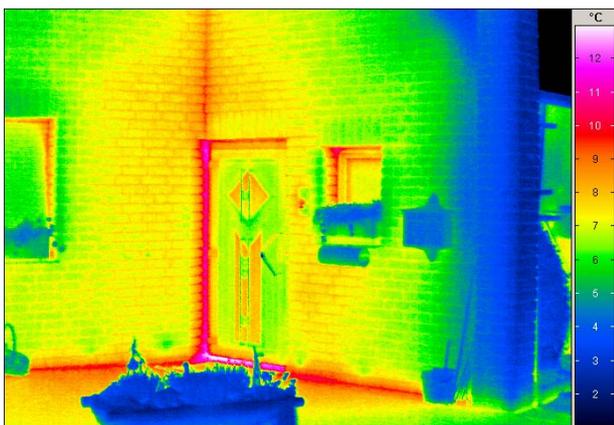
Poorly insulated door framing and failing wall- floor connection

ARCHIMEDES uses its infrared camera predominantly for revisions and securing of quality standards during the construction phase of newly erected buildings and the refurbishment of older buildings. Thereby the detection of construction faults like thermal bridges, poor insulations or air leakages plays a major role. Also weak points at window or door framings can easily be located. Besides, for

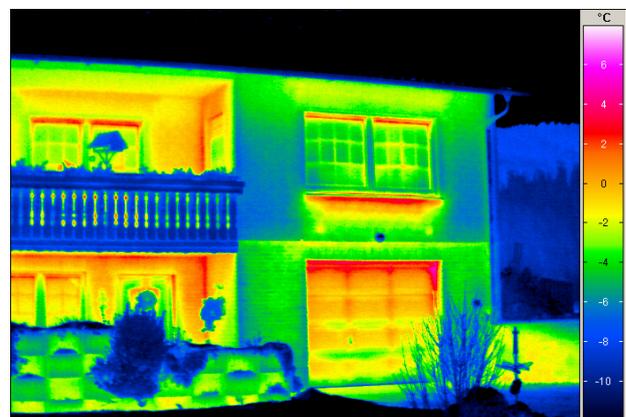
Heat loss below the window and at the door of the garage
